IN THE UNITED STATES DISTRICT COURT
FOR THE NORTHERN DISTRICT OF TEXAS
ABILENE DIVISION

CIVIL ACTION NO. 1:18-CV-00062

**APPENDIX TO PLAINTIFF'S BRIEF IN SUPPORT OF ITS RESPONSE TO
DEFENDANT'S RENEWED MOTION FOR PARTIAL SUMMARY JUDGMENT**

Exhibit	Title	App. Range
A	Affidavit of Scott Taliaferro, Jr.	Pp 3-43
B	Affidavit of Mark Reed	Pp 4-51
C	Excerpts of the Deposition of Leslie Ederer	Pp 52-103
D	Pratt & Whitney Canada Engine/Component Investigation Report	Pp 104-131

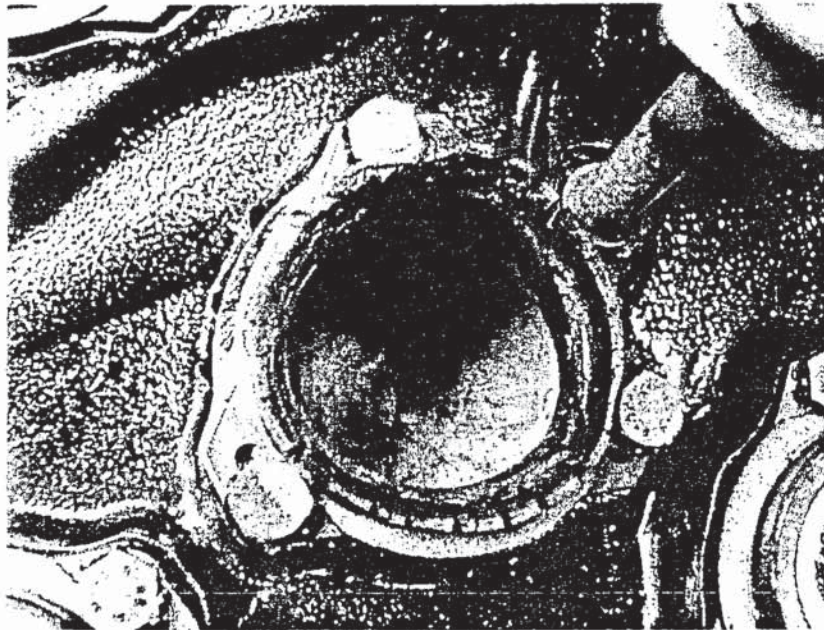
Photo No. 13

- 2.9 The AGB diaphragm was split from the AGB housing revealing metal debris contamination and the distorted remnants of the flanged outer ring of its accessory bearing (P/N 3037278 from records, as P/N and S/N not legible) at diaphragm boss No. 3 (arrow, Photo Nos. 12 and 13). The triple key washer was in place with the tabs properly secured. The bearing seat was also damaged and cracked in line with the retaining bolt holes (arrows), resulting in the displacement of the helicoil inserts during the bearing removal (Photo No. 14). The remaining accessories roller bearings showed no distress. The external scavenge pump gearshaft drive and the oil pump drive gearshaft showed no primary distress only secondary damages from overrunning metallic debris (Photo No. 12). The flanged oil transfer tube was found unobstructed (red arrow, Photo No. 12).

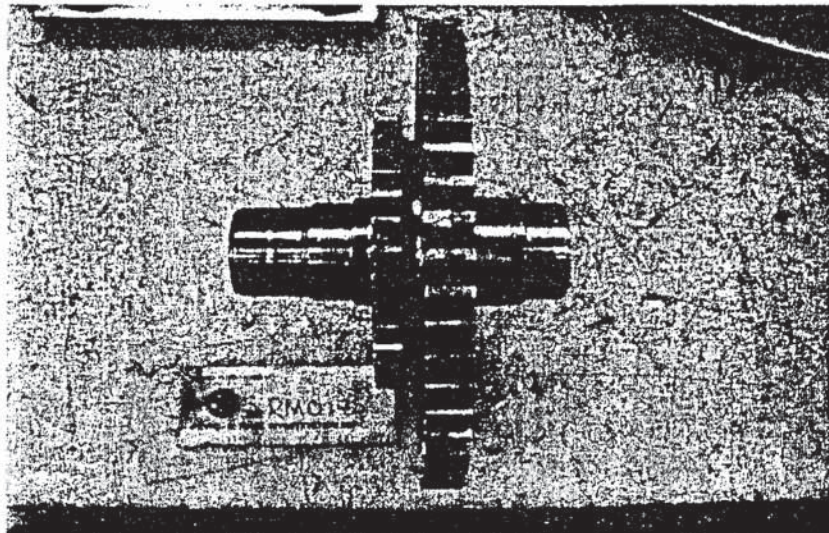
Photo No. 16

- 2.10 The AGB housing showed metal debris contamination (Photo No. 15). The gearshafts except the AGB drive gearshaft were removed. The starter generator gearshaft drive and an accessory gearshaft drive showed secondary mechanical damages (Photo No. 16). The centrifugal breather impeller showed material loss from the outer circumference from contact with the AGB drive gearshaft teeth (Photo No. 17). The fuel control drive gearshaft and second accessory gearshaft drive showed no significant damages.

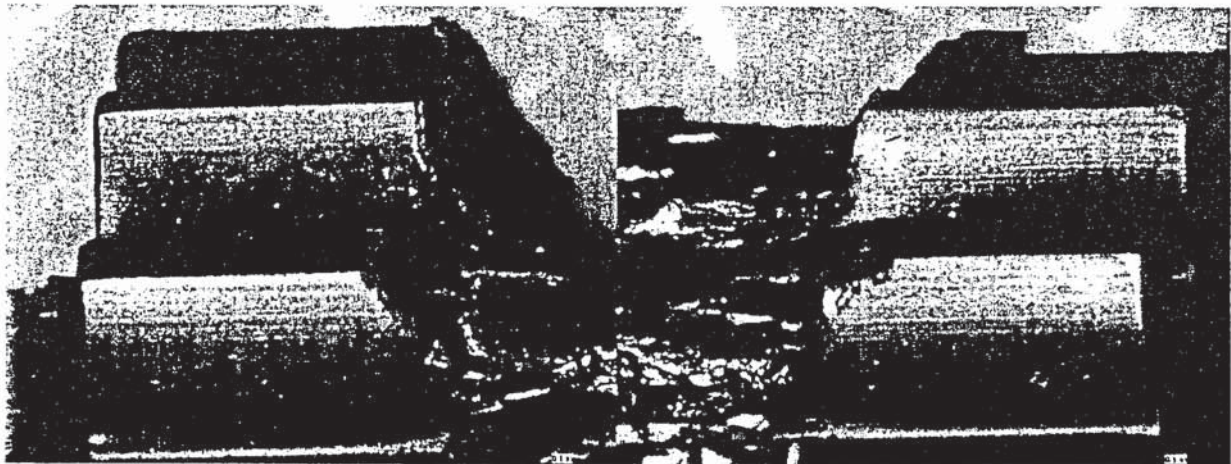
Photo No. 21

- 2.12 Removal of the AGB drive gearshaft revealed the distorted remnants of the flanged outer ring of its accessory bearing (P/N 3037278 from records, as P/N and S/N not legible) at housing boss No. 3 (Photo No. 21). The flat spacer, and triple key washer was in place with the tabs properly secured. The bearing support sleeve seat showed rubbing damage (Photo Nos. 22 and 23). The remaining accessories bearings showed no distress (Photo No. 23).

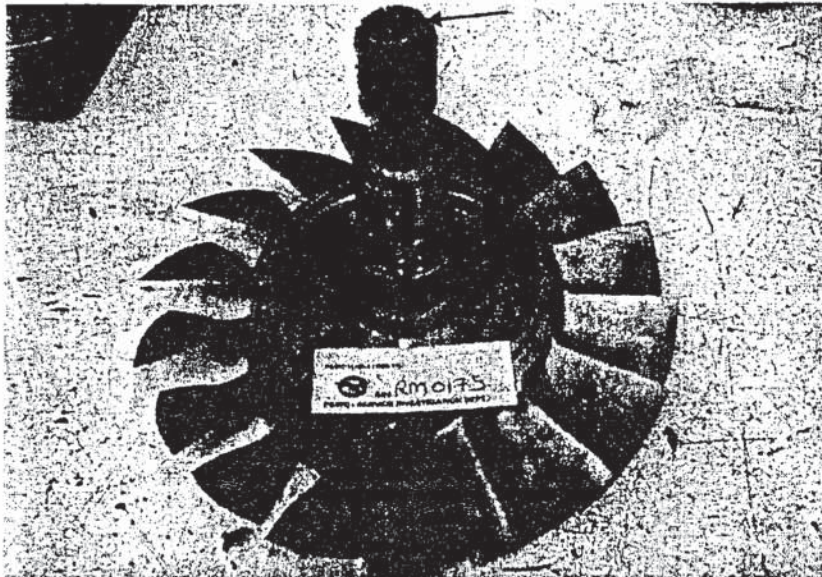
Photo No. 25

- 2.14 The compressor was accessed to remove the compressor rotor assembly with the rear hub coupling sleeve (arrow) still inside the compressor rear hub coupling (Photo No. 25). The compressor rear hub coupling was found to have slightly rotated within the compressor rotor shaft based on the offset view of the shear pin used to retain the two parts (circled, Photo No. 26). The splines on the compressor rear hub coupling showed two distinct contact patterns (Photo No. 27). The contact pattern which showed normal contact wear was observed to begin closer towards the compressor rotor end than second contact pattern. The second contact pattern, which showed excessive contact wear and heat discoloration, was located approximately 1/8" more rearward of the start of the first contact pattern. The pin ball lock in the compressor rear hub coupling was found with a concave depression worn into the tip (arrow, Photo No. 28). The coupling sleeve, spring expander, pin ball lock were removed from the compressor rear hub coupling. For comparison the worn pin ball lock (on left) is placed next to an acceptable in-service pin ball lock (on right) showing the extent of the wear (Photo No. 29). The coupling sleeve showed mechanical impressions of spline teeth around the periphery of the outside flange (Photo No. 30). The locking feature of the spring expander had fractured and the inner diameter showed polishing / rubbing from expander leg movement (Photo No. 31). Examination of the coupling shaft (P/N 3119369-01) splines showed wear only on one side of the splines (red arrows) except for one spline which showed a localized worn region near the front end of the spline that extended to both its sides (circled, Photo No. 32). The wear was similar to the wear observed on the pin ball lock.

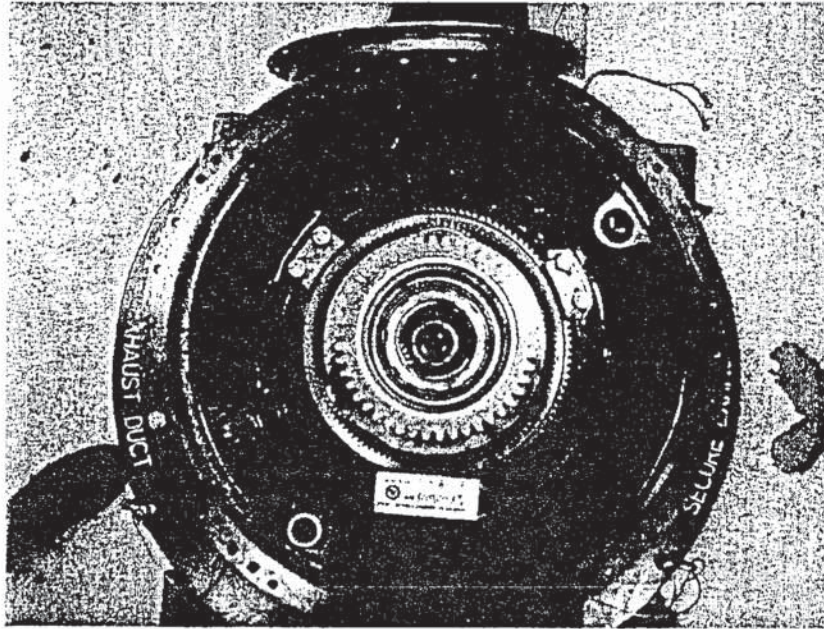
Photo No. 33

- 2.15 The RGB was removed and disassembled revealing the first stage carrier flange at the location of the planet gears "X" and "Z" to be significantly heat tinted (Photo No. 33). All three first stage planet gears could be rotated. The planet gear carrier bearing journal showed no distress. The planet gear carrier was disassembled, but due to distress of the "X" and "Z" planet gears' bushings they could not be removed (Photo Nos. 34 and 35). Removal of the oil strainers, showed the "X" and "Z" planet gears were discolored with carbonised oil, showed no evidence of any oil wetness (Photo No. 35). The second stage carrier assembly showed no distress.

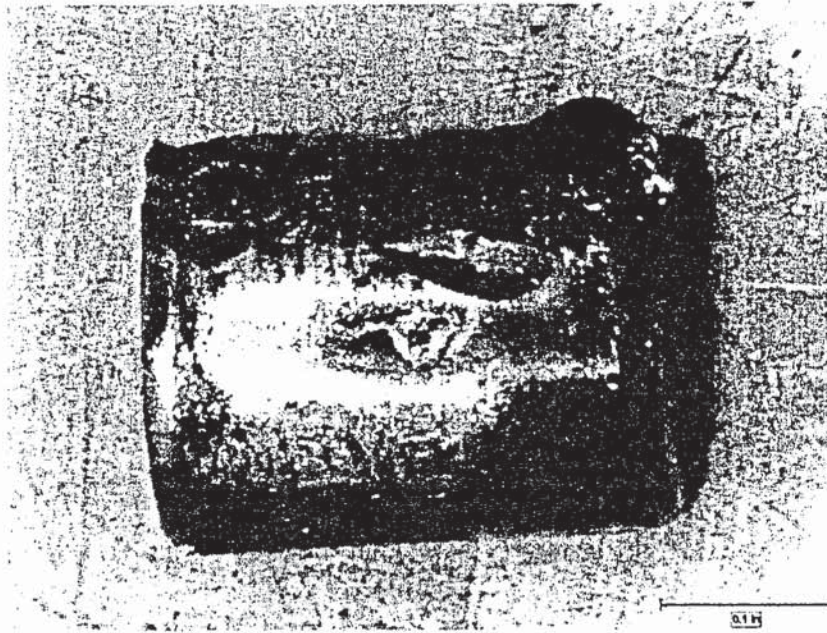
Photo No. 37

- 2.16 From the debris recovered in the AGB front housing 13 rollers, pieces of bearing cage crossbars and side rails were found and (Photo No. 36). It could not be determined from which of the two accessories bearings (10 rollers each) the rollers and cage pieces had originated from. Due to the damages on all the recovered rollers and cage cross bars it was not possible to characterise their condition prior to the damages (Photo Nos. 37 and 38). The cage side bars that could be characterised showed significant roller end face contact wear resulting in wear ridges corresponding to the outside diameter of the rollers (arrows, Photo No. 39). Although many of the side rails fracture surfaces showed significant rubbing obliterating the original fracture surface (Photo No. 40) some still showed evidence of river lines (arrows) and a flat region indicative of fatigue (Photo No. 41).

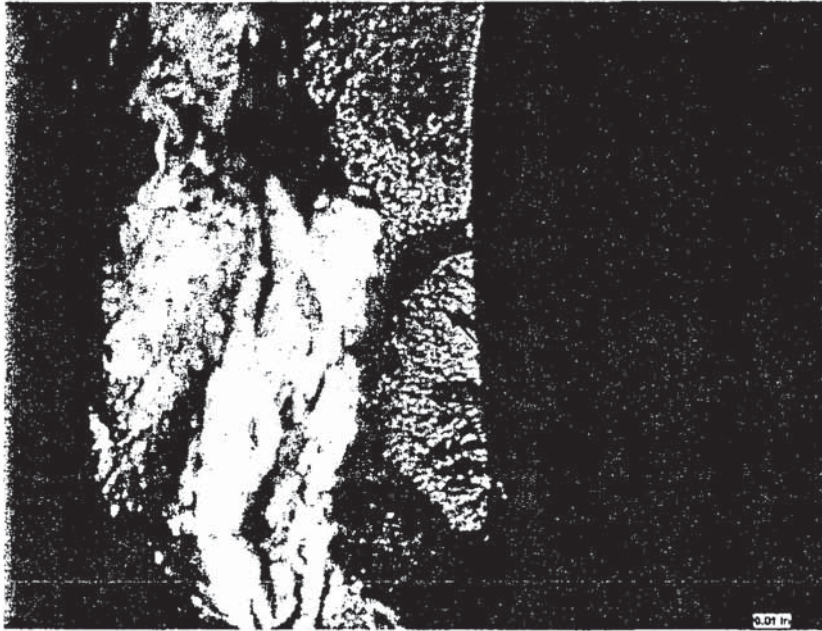
Photo No. 47

- 2.19 The spring lock insert fracture surfaces showed significant rubbing damages, however in small undamaged regions the original fracture surface could still be observed (Photo No. 46). The fracture surface morphology of these regions showed flat surfaces with, river lines and beach marks indicative of fatigue crack propagation (Photo No. 47). The fracture surfaces on the spring lock legs showed similar features (Photo No. 48).
